# ROCK CRUSHER BEARING HOUSING REBUILT WITH BELZONA

ID: 5258

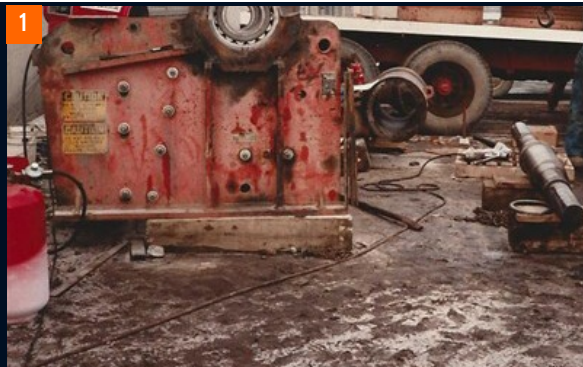
1. Jaw Crusher
2. Forming bottom half of new bearing housing.
3. Rebuilt bearing housing showing Bondo used to maintain the bearing grease groove.

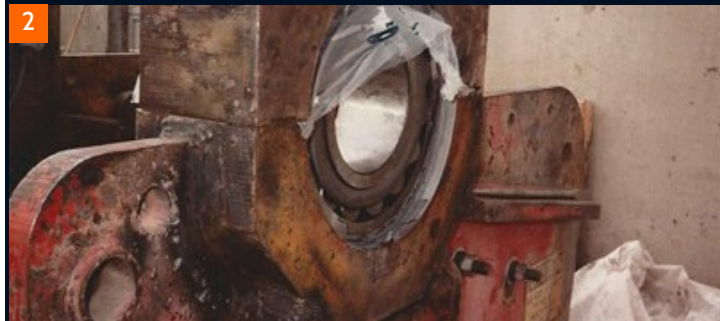
The bearing seized causing the housing to become oversized.

Bearing housing worn oversize.

Tabs were welded on to center the new bearing. 'Bondo' was used to fill the grease groove in the new bearing. The new bearing housing was formed one half at a time. Even with the Release Agent the 'Bondo' stuck to Belzona 1111. After the new housing was complete the 'Bondo' was removed with a chisel. The application was carried out in accordance with Belzona Know-How System Leaflet ENC-3b.
