# KNOW-HOW AND BELZONA 4111 MAKE CRITICAL REPAIR

ID: 526

Cooling tower

Power Plant - Texas U.S.A.

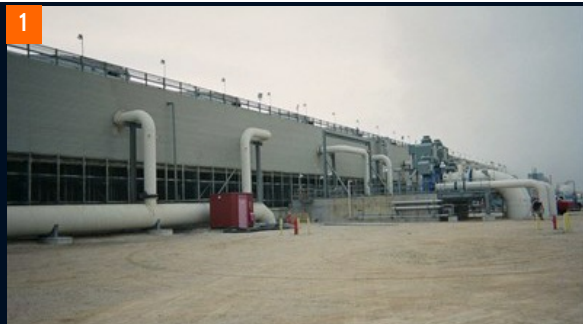
1. Cooling tower at power plant
2. Acid damaged concrete support
3. Belzona 4111 applied using formers
4. Finished project

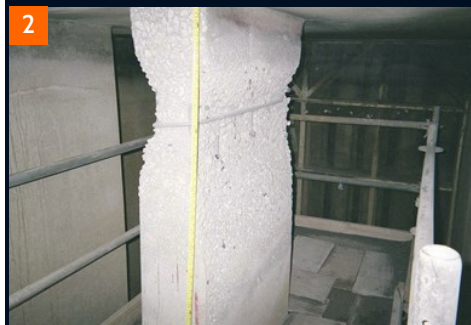
Lack of sufficient mixing of acid used for pH control in cooling tower water caused concrete deterioration on critical support members of cooling tower.

A short outage was planned to make other repairs in the cooling tower when damage was discovered. Client needed a quick solution. Belzona Know-How and its quick-curing Belzona® 4111 allowed this repair to be made in the short shut down period allowed. Acid feed has since been moved to prevent future damage.
