# BELZONA REPAIRS ENGINE CASING

ID: 5260

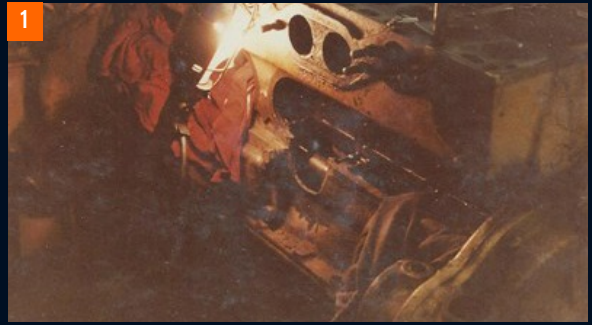
The engine block had a large piece of the casing broken off.

1. Engine block showing missing pieces
2. Two pieces locked in place with studs
3. Completed application with Belzona 1111
