# BELZONA SAVES DRAIN DAMAGED BY CHEMICALS

ID: 5261

Damaged concrete in kitchen drain.

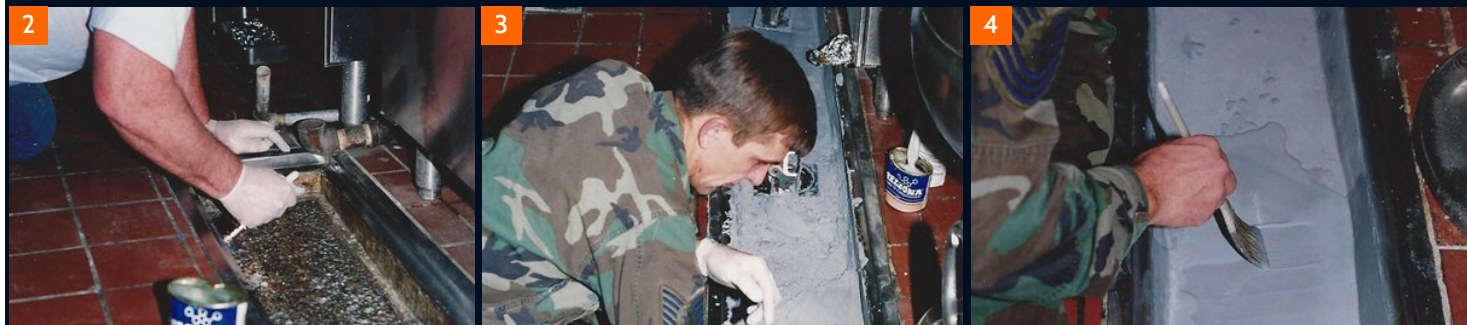
Chemicals used to clean equipment in the kitchen were destroying the concrete in the drain.

1. Grinding the steel drain
2. Conditioning the concrete
3. Troweling in the Belzona 4111
4. A coat of Belzona 4311 brushed over the drain surface

The application was carried out in accordance with Belzona Know-How System Leaflet FPA-3. The concrete was cleaned and the steel was ground. Belzona 4111 was troweled over the area. A coat of Belzona 4311 was brushed over the surface, including the steel drain, to protect from chemical attack.
