# BELZONA SAVES MONEY WITH RUNWAY LIGHT REPAIR

ID: 5262

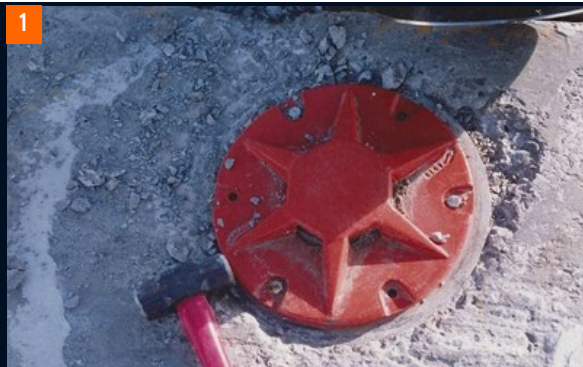
The runway lights protruded above the runway. If a snowplow hit one it would need replacement, which costs \$700 for each.

1. Runway light showing the previous ramping material removed
2. Conditioning the surface
3. Troweling down Belzona 4111
4. Completing the application with Belzona 4111 after the forming lid was removed

A lid was made as a former so the light cover can be removed for servicing after Belzona 4111 was applied. The concrete was roughened and Belzona 4111 was troweled down to form a "ramp" around the runway light. After full cure a snowplow was used to drive over the ramp dropping the plow at 50 MPH. There was no damage to the ramp.
