# BELZONA IMPROVES SAFETY WITH NONSKID SURFACE

ID: 5263

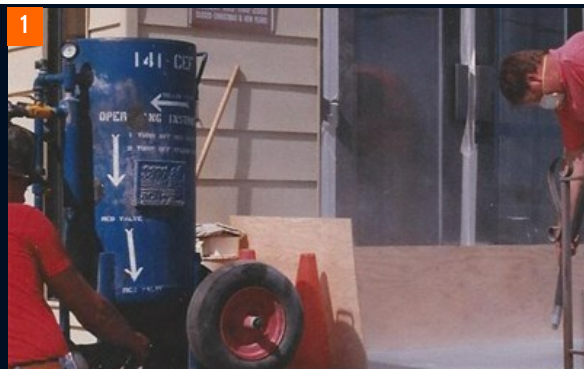
1. Blasting the concrete
2. Brushing on Belzona 4411
3. Sprinkling on Belzona 9221
4. Completed application

Application was carried out in accordance with Belzona Know-How System Leaflet FPA-8. The surface was blasted to remove all surface laitence. Belzona 4411 was brushed onto the surface and Belzona 9221 was spread on top.
