# BELZONA AVOIDS COSTLY DOWNTIME BY PATCHING FUEL BLADDERS

ID: 5265

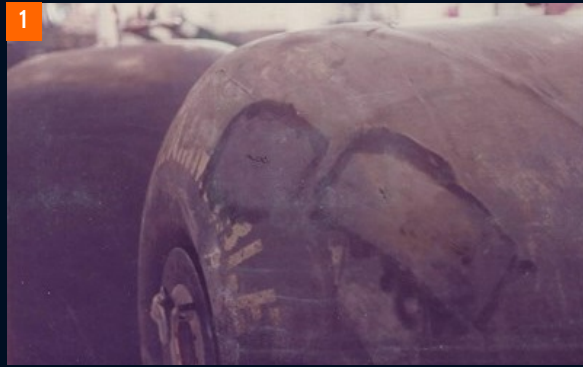
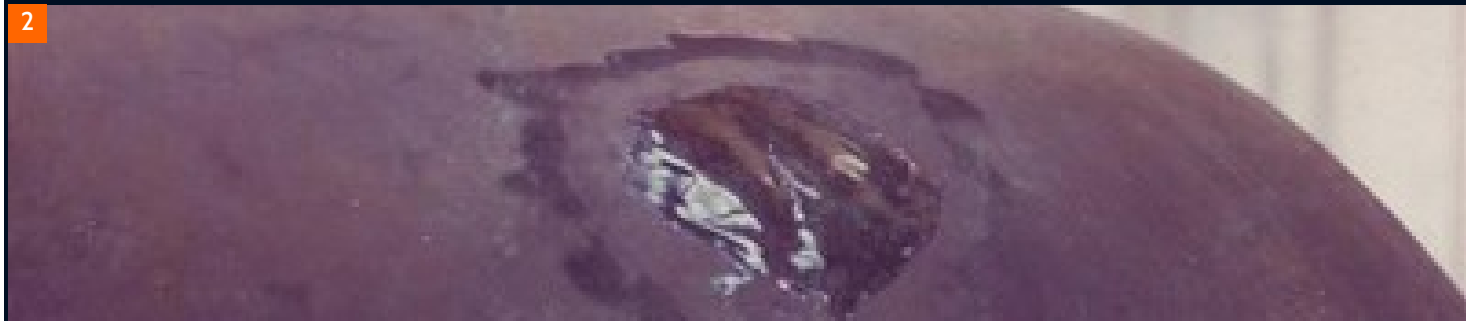
Scrapes on the outer rubber layer of the large towable fuel bladders would allow water to wick into the fabric, weakening the fuel bladder.

1. Bladder showing damage and prepared for conditioner
2. Completed application

Application was carried out in accordance with Belzona Know-How System Leaflet SHM-9. The surface was roughened and Belzona 2911 was applied and allowed to cure. Belzona 2221 was brushed on and Belzona 9341 was stippled in. Two hours later a final coat was brushed over the surface.
