# BELZONA SAVES WASTEWATER GRIT PUMP

Wastewater grit pump.

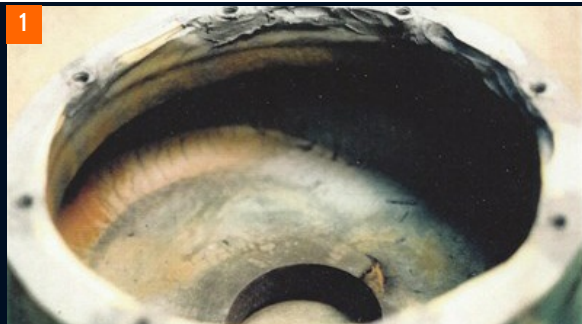
This grit pump got extremely worn and had been rebuilt with an alternative method, which lasted only 3 months.

1. Pump bowl with threads rebuilt
2. Pump bowl coated with Belzona 1811
3. End cover showing wear
4. End cover with Belzona 2111 formed in place; excess needs to be trimmed

The application was carried out in accordance with Belzona Know-How System Leaflets CEP-3 & CEP-5. The threads that were worn through were rebuilt with Belzona 1311. The bowl was lined with Belzona 1811. The end cover was rebuilt with Belzona 2111 as a comparison to Belzona 1811.
