# BELZONA KEEPS AIRPORT COOL WITH HEAT EXCHANGER REPAIR

ID: 5267

Corroded heat exchanger.

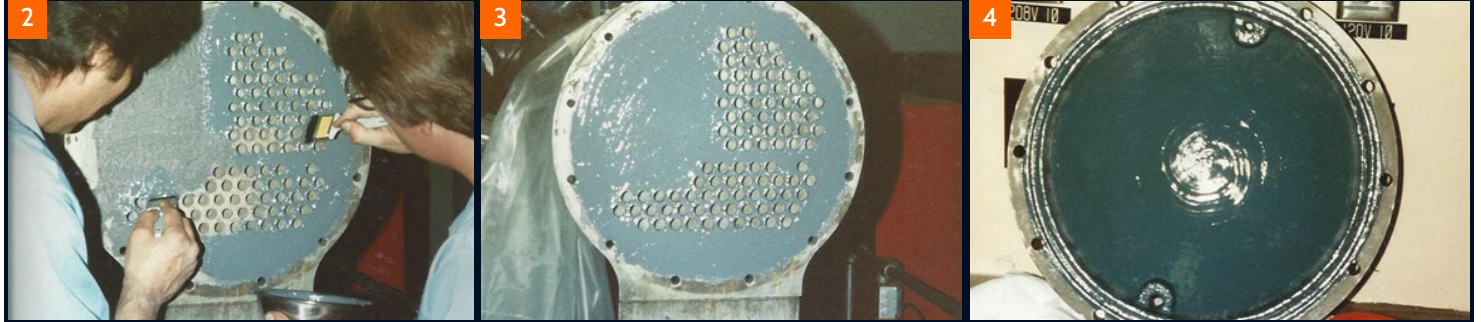
## PHOTOS

Corrosion caused by the chemicals in the system were eating away the tube sheet and end cover.

1. Corroded tube sheet
2. Brushing on Belzona 1321
3. Completed application on the tube sheet
4. Completed application of the coating on the end cover

The tube sheet and end cover were blasted and coated with two layers of Belzona 1321. It was decided to not use corks because the tube sheet was small. The application was carried out in accordance with Belzona Know-How System Leaflets HEX-1 & HEX-2.
