# BELZONA OFFERS A SOLUTION TO REPAIR BUSHINGS

ID: 5271

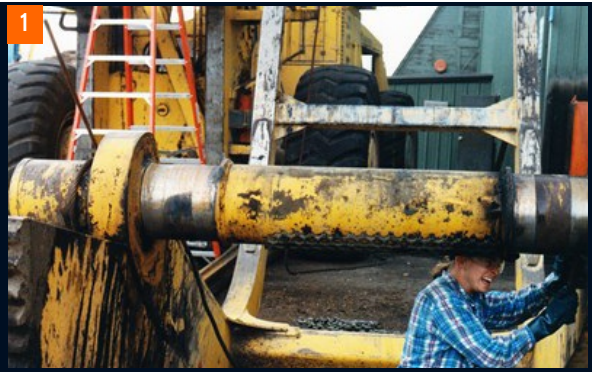
With the fork bushing worn out, the forks would bind, causing trouble unloading log trucks.

1. Worn shaft areas where bushing ride
2. Former built by their own machine shop
3. Former being bolted in place
4. Log loader ready to return to service

The application was carried out in accordance with Belzona Know-How System Leaflet MPT-2. A former was built in the machine shop and tabs were welded to center it on the "shaft".
