# BELZONA REPAIRS BUSH HOUSINGS

ID: 5272

Log loader bush housings.

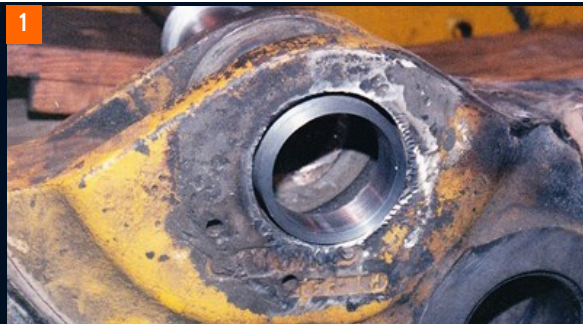
The bush housings were worn oversize.

1. New bushings set in to show amount of wear
2. Grit blasting the housings
3. Bushings in place with shaft for alignment

Application was carried out in accordance with Belzona Know-How System Leaflet MPT-8. The housings were grit blasted. Belzona 9411 was brushed onto the new bushings. Belzona 1111 was applied to both surfaces and the bushings were twisted into place. A long shaft was inserted to align the four bushings.
