# BELZONA IMPROVES SAFETY WITH GRIP SYSTEM ON STEPS

ID: 5273

Nonslip on football stadium steps.

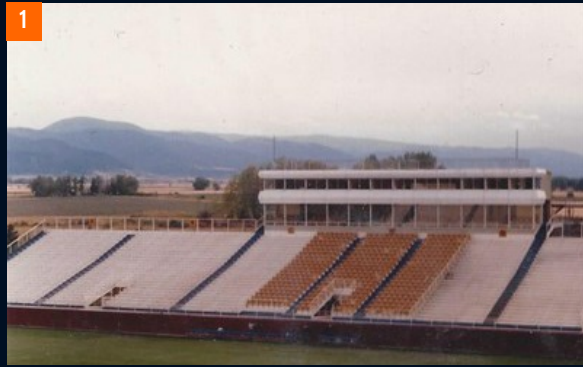
1. Overview of football stadium
2. Nosings blasted and masked off
3. Brushing on Belzona 4411
4. Completed application, ready for repainting
