# BELZONA RESETS BUSHINGS ON P&H SHOVEL

ID: 5276

Worn bushings on P&H Shovel.

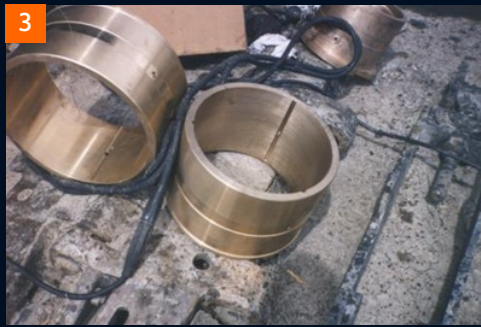
The 16 inch diameter bores on the final drive of this P&H Shovel were badly worn.

1. P&H Shovel.
2. General view of disassembled P&H Shovel drive unit.
3. New bushings coated with Belzona 9411. Prior to insertion oil and grease channels are filled with a firm paraffin wax to ensure they do not get blocked. Once set, the area is heated to soften the wax so that it can be pumped out with new grease.
4. Completed application.
