# BELZONA PROVIDES EMERGENCY REPAIR ON A WORN CONVEYOR BELT

ID: 5277

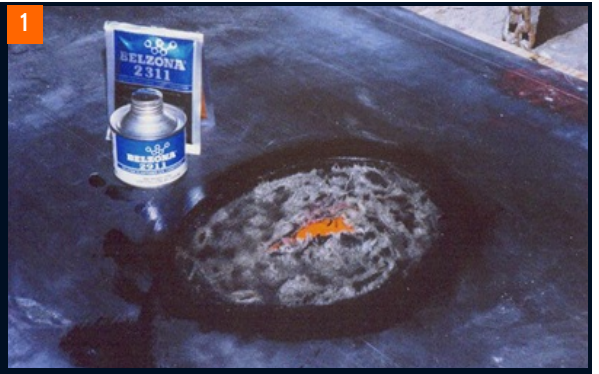
A large hole had formed in this conveyor belt, causing an interruption in production.

1. Damaged conveyor belt, ready for repair.
2. Close up of repair area showing the use of the Belzona mixing surface, which was positioned underneath the belt to act as a suitable temporary backing for the repair.
3. Completed application.

A large hole on the conveyor belt threatened to interrupt production. The use of Belzona 2311 enabled maintenance and completed the necessary repair. Belzona reinforced the conveyor belt with a minimum amount of downtime and also prevented the loss of production.
