# BELZONA: STOPS LEAKS IN COOLING TOWERS

ID: 528

Cooling tower basin

Power Plant in South Texas

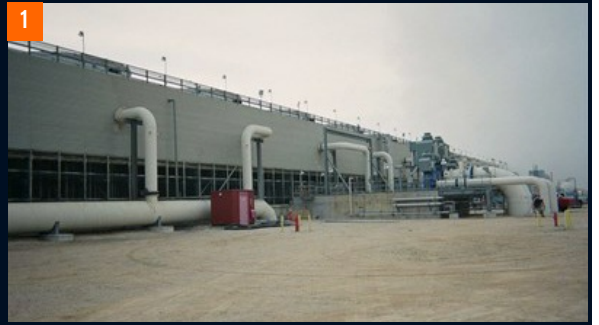
1. Cooling tower
2. Expansion joints being prepared
3. Belzona 2221 being poured into backed joints
4. Finished joint holds back rainwater

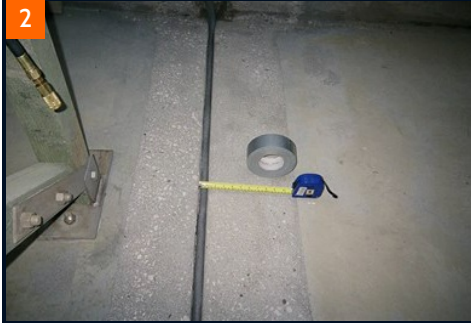
Leaking water was causing economic concerns. The old joint sealants had worn down and ground movement caused leaks in the concrete floor and walls.

The application was carried out in accordance with Belzona Know-How System Leaflet HEX-13b.
