# BELZONA REPAIRS BUTTERFLY VALVE GASKET

ID: 5280

The butterfly valve from the main circulating water system of the power plant was removed for maintenance and required a new gasket prior to reinstallation.

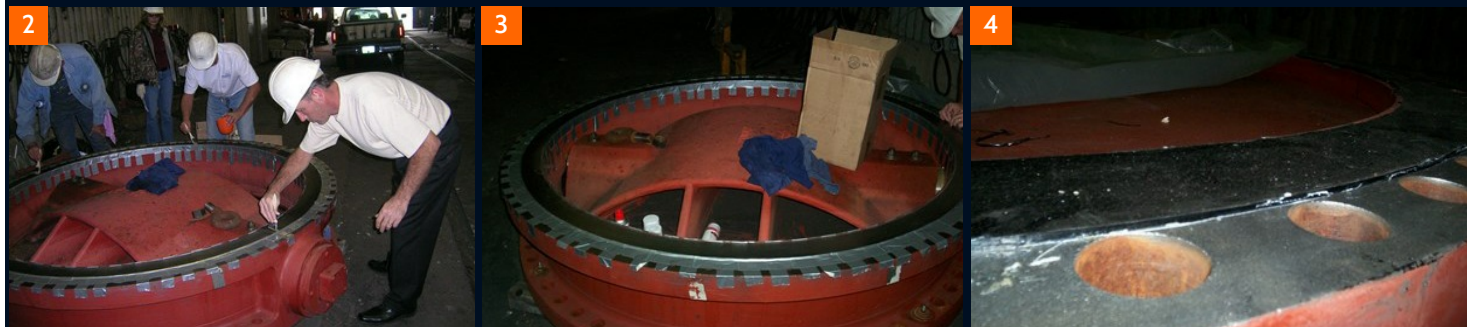
## PHOTOS

1. Blasted butterfly valve gasket
2. Application of product
3. Finished repair
4. Close-up of gasket prior to installation

The application was carried out in accordance with Belzona Know-How System Leaflet GSS-1 using Belzona 2131. After grit blasting the surface, heavy gauge wire was used to form a channel to apply Belzona 2131 to the proper thickness.
