# BELZONA SEALS ABSORBER TO PROTECT AGAINST EROSION-CORROSION

ID: 5281

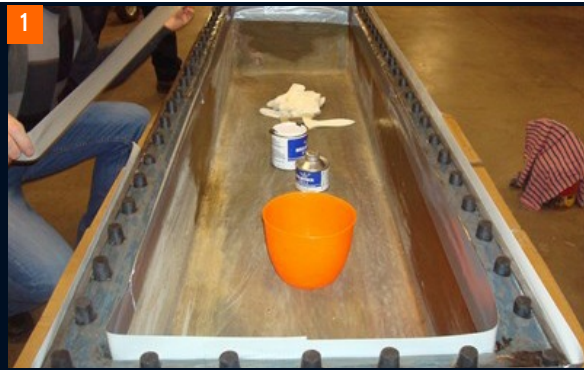
1. Absorber channel prepped; edge built with duct tape to hold the elastomer
2. Application of Belzona 2131
3. Final picture of finished gasket
4. Side-view of absorber with gasket reassembled/in-service

The application was carried out in accordance with Belzona Know-How System Leaflet GSS-1 using Belzona 2131. After preparing the surface, tape was used to form a channel to apply Belzona 2131 to the proper thickness and stoppers were inserted into the bolt holes. Belzona 9411 was used for the corks inserted into the bolt holes.
