# BELZONA REBUILDS CONVEYOR DRIVE SHAFT IN PLACE

ID: 5282

Conveyor drive shaft

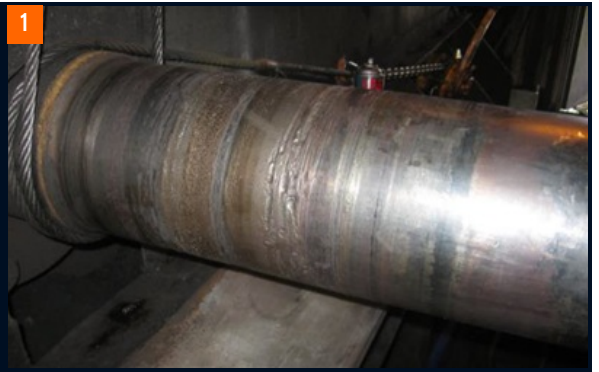
This 8" diameter shaft carries the head pulley of a large conveyor belt. The bearing seat on the drive end was heavily scored worn more than 1/4" undersize.

1. Damaged bearing seat
2. Split mould coated with release agent
3. Mould clamped on shaft with injection tubes in place
4. Shaft with repaired bearing seat ready for service
