# BELZONA REBUILDS ERODED KEEL COOLER

ID: 5283

Eroded keel cooler

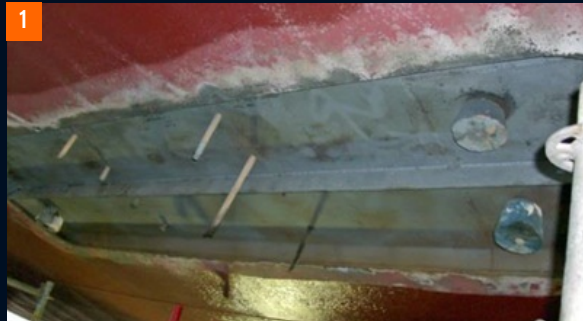
The keel cooler metal was suffering from corrosion pitting.

1. View of corrosion.
2. Corroded and pitted areas rebuilt.
3. Completed application. Entire cooler surface protected.
