# BELZONA'S REPAIR ALLOWS FOR A QUICK RETURN TO OPERATION

ID: 5284

Baler loader at a busy recycling paper mill.

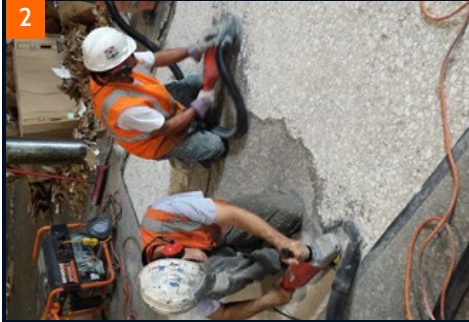
The concrete floor had begun to wear away due to abrasion from forklifts sliding bales into the conveyor. The steel was also excessively worn, causing a 2" lip for the bales to overcome.

1. Wear at loading point
2. Surface preparation with diamond grinding
3. Completed application
