# BELZONA PERFORMS A CLASSIC REPAIR

A small crack had developed in the 2.8 litre engine casing of this 1951 David Brown Lagonda.

Engine casing on vintage car

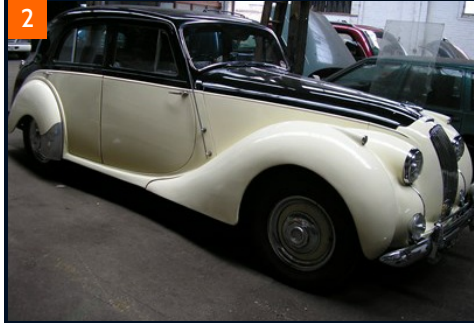
1. The engine block
2. The exterior of this fully restored classic car
3. The cars interior
4. The rear view of the car

Application was carried out in accordance with Belzona Know-How System Leaflet ENC-1.

Belzona was chosen as being the quickest, simplest and cheapest method of conducting the repair. Other alternatives would have involved welding, which the client did not want to pursue due to the age of the casting. The repair needed to be carried out quickly as the car was to go on show the following day. The total cost was around £15 (\$28) to complete.

Belzona 1111 (Super Metal)

Belzona 9341 (Reinforcement Tape)
