# BELZONA REPAIRS ERODED AND CAVITATED RUDDER HORN

ID: 5295

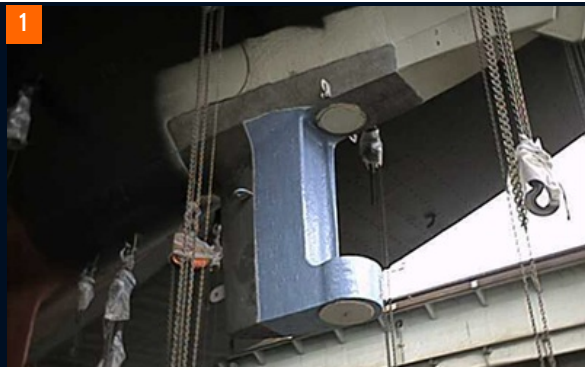
Bi-metallic corrosion had eroded much of the metal around the pintle mounting area, while the leading edge was subject to severe cavitation attack.

1. View of application in progress.
2. Application of Belzona 2141 in progress.
3. Completed application.

Belzona 1311 rebuilt the eroded trailing portion of the horn. Then it was protected with 2 coats of Belzona 1341. Leading edge was primed with Belzona 2941 in preparation of Belzona 2141 application. The application was carried out in accordance with Belzona Know-How System Leaflets SOS-1 and SOS-2.
