# BELZONA REPAIRS A CRUSHER'S BOWL LINER BASE

ID: 5297

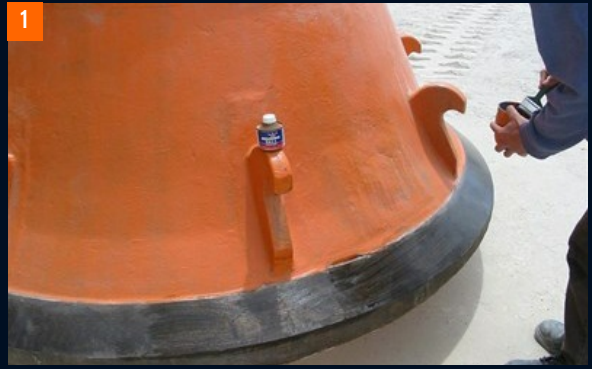
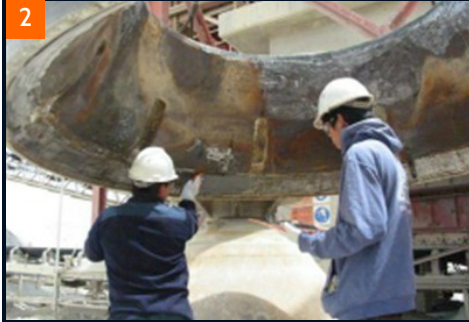
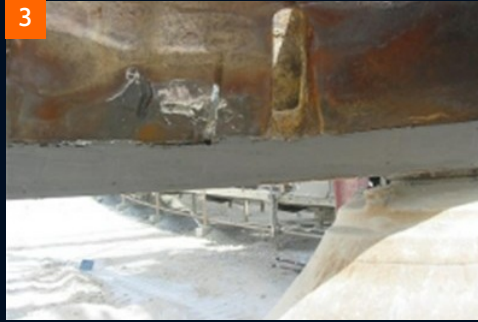
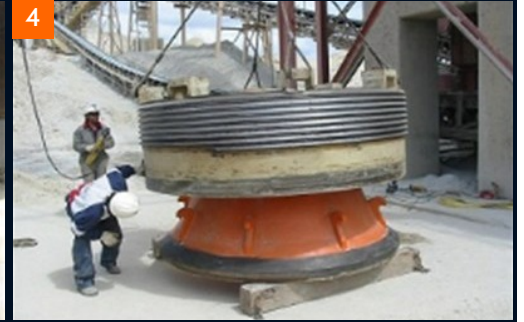
1. Application of Belzona 9411 on the area of the bowl liner
2. Application of Belzona 1111 on the fastener of the base of the bowl liner
3. Application of Belzona 1111
4. Installation of the fastener over the bowl liner

The damaged area on the base of the fastener of the bowl liner was cleaned. Belzona 9411 was applied on the bowl liner, Belzona 1111 was applied at the base of the fastener of bowl liner and the pieces were later joined, before Belzona 1111 could cure to make a mold.
