# A WINDOW OF OPPORTUNITY FOR BELZONA

ID: 530

Concrete Lintels

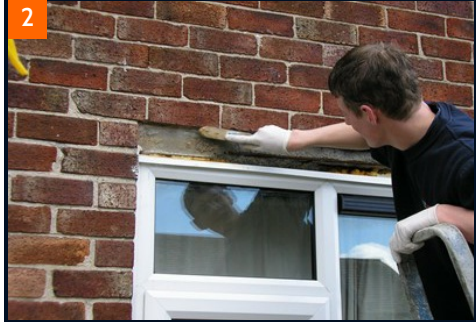
The concrete lintels had spalled revealing the reinforcement bars underneath. The Housing Association were fitting new windows and wanted repairs carried out quickly and effectively.

1. The damaged lintels
2. The area being cleaned and prepared
3. Belzona 4141 being applied
4. Finished lintel
