# BELZONA COATS CAPSTANS AND SAVES CUSTOMER THOUSANDS OF DOLLARS

ID: 5300

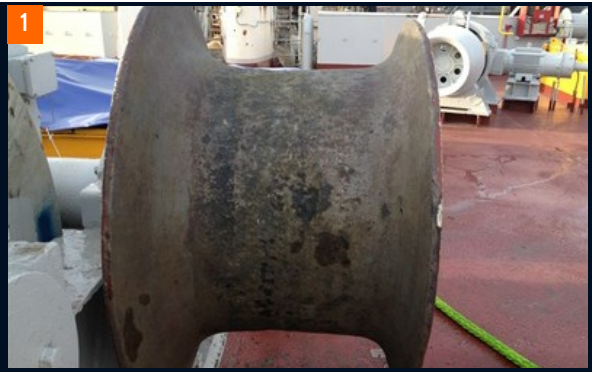
Capstans had been pitted and deformed because of chains that had been used to anchor to dock. Chains had been replaced by new technology rope which were being damaged by the uneven and rough capstan surfaces.

1. Capstan after hydro-blasting
2. Belzona 1311 being applied by Technician
3. Belzona 1341 final coating
4. Finished product on both capstans

Application was carried out in accordance with a modified version of Belzona Know-How System Leaflet SOS-2.
