# BELZONA REBUILDS ERODED RUDDER PINTLE HOUSING

ID: 5301

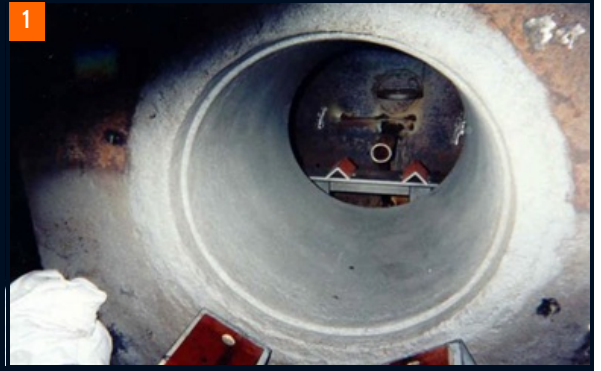
Bi-metallic corrosion had eroded much of the metal (about ¼ inch) from the rudder pintle housing.

1. View of blasted rudder housing.
2. Housing coated with Belzona 1321 to increase slip factor.
3. Rudder in position on horizontal slide partially inserted.
4. Rudder pintle inserted and allowed to set up before being removed with the aid of a 30 ton hydraulic jack. The reformed bore was inspected by the ships insurers and found to provide almost 100% contact.
