# BELZONA SEALS SKYLIGHT TO PREVENT WATER PENETRATION

ID: 5302

A skylight on the roof of a building.

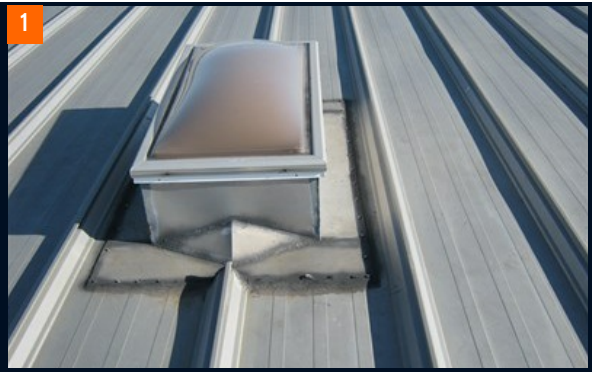
Water penetration between roofing sheets and around the skylight.

1. Prior to application
2. Preparation in progress
3. Application in progress
4. Completed application
