# BELZONA REPAIRS AND RESURFACES FLOOR

ID: 5303

Floor area at a food production facility.

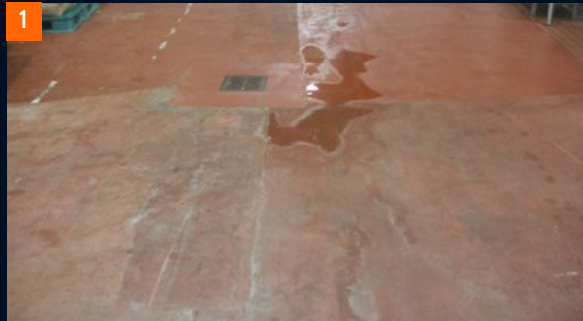
Over time, the floor had settled, resulting in standing water not flowing into the drain. This created an environmental hazard.

1. Prior to application
2. Preparation in progress
3. Completed preparation
4. Completed application
