# BELZONA PREVENTS CORROSION CAUSED BY SWEATING PIPE WORK

ID: 5304

Pipe work at a pumping station.

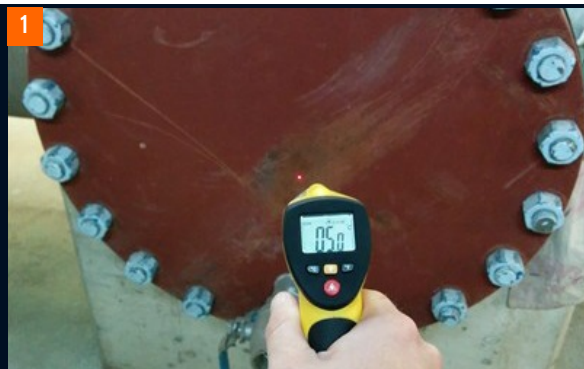
Corrosion on the carbon steel caused by sweating pipe work.

1. Prior to application
2. Completed application
3. Completed application
4. Close-up of completed application

The application was carried out in accordance with Belzona Know-How System Leaflet VPF-2 for applying erosion-corrosion resistant coatings. The surface was abrasive blasted to prepare the area and Belzona 5831 was applied directly onto the prepared surface with a short bristled brush, scrubbing the product well into the surface to ensure complete wetting as a two coat system.
