# BELZONA REPAIRS VOITH SCHNEIDER PROPULSION UNIT

ID: 5305

A Voith Schneider unit from a passenger ferry.

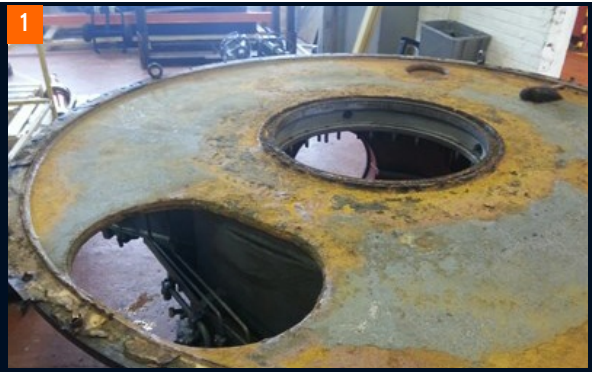
The combination of sea water and erosion from silt and sand was creating an erosion-corrosion cycle. Extensive metal loss had been noticed on the face of the equipment and on the inner rims.

1. Voith unit before work started 2. The damage on the inner rim 3. Belzona 1311 applied & former in place 4. Former removed, rim rebuilt and face coated with Belzona 1321

The application was carried out in accordance with Belzona System Leaflets SOS-1 & 2. The unit was grit blasted and salt tested. The inner rim was then built up using a pre-fabricated metal former. The face was also built back up using Belzona 1311. Belzona 1321 was then applied to coat & protect the unit from future erosion/corrosion.
