# BELZONA PROTECTS ACID VESSEL FROM CHEMICAL ATTACK

ID: 5306

Acid production vessel.

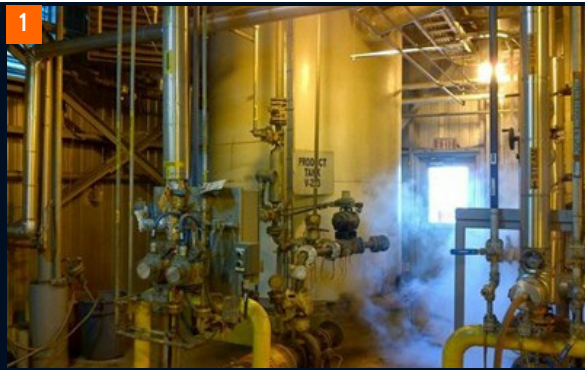
1. Acid vessel
2. Prior to application
3. Application in progress
4. Completed application

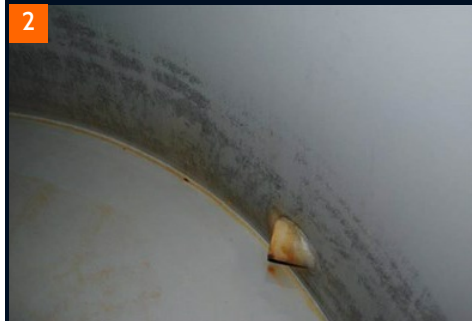
The acid had damaged the teflon coating.

The application was carried out in accordance with Belzona Know-How System Leaflet TCC-3 for repairing/renewing damaged linings. Abrasive blasting was done to prepare the surface and Belzona 4311 was spray applied as a two coat system in accordance with Belzona Instructions For Use.
