# BELZONA SEALS HOLE IN GLASS LINED REACTOR

ID: 5307

Glass lined reactor.

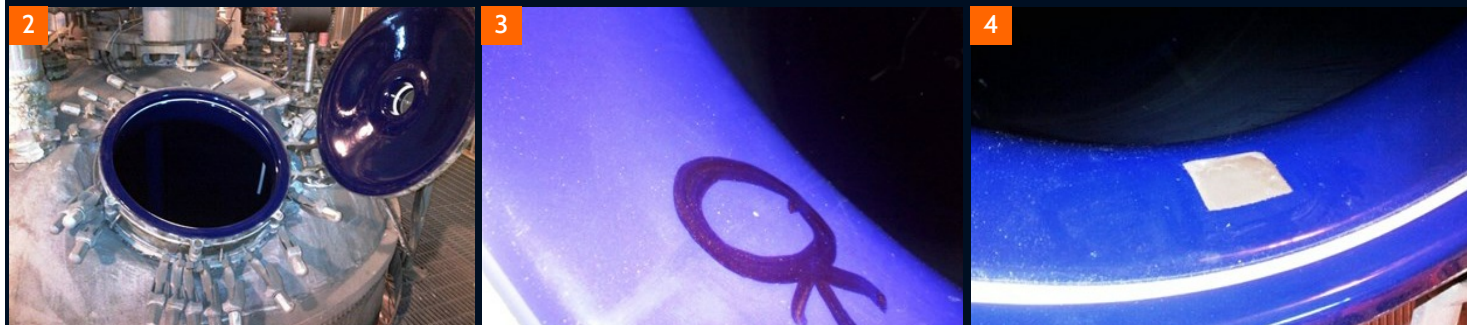
1. Overview of glass lined reactor
2. Glass lined reactor
3. Prior to application
4. Completed application

Lining had suffered from impact damage, resulting in a small hole in the lining. This made the reactor unusable.

The application was carried out in accordance with Belzona Know-How System Leaflet TCC-1 for sealing cracks, porous welds, bolted and riveted joints on tanks. The surface was ground. Belzona 1591 was applied with an applicator and brush in accordance with Belzona Instructions For Use.
