# BELZONA REBUILDS & PROTECTS PUMP IMPELLER

ID: 531

Impeller from effluent sewage pump.

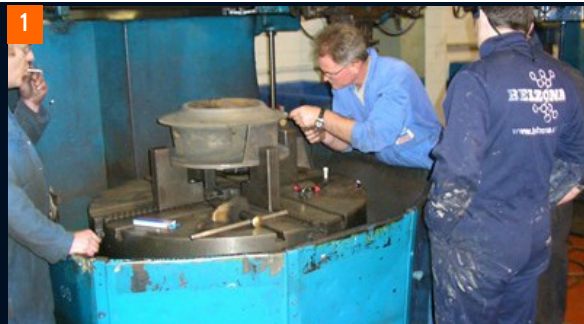
Impeller had moved on its shaft causing it to run against the casing. This resulted in severe abrasive wear and mechanical damage.

1. Impeller on vertical borer prior to cleaning and refurbishment
2. View of wear and mechanical damage. Wire framework was used to reinforce repair
3. Application of Belzona 1111 underway
4. Completed impeller after application of final coats of Belzona 1321
