# BELZONA REPAIRS AND COATS RUBBER SOCK

ID: 5314

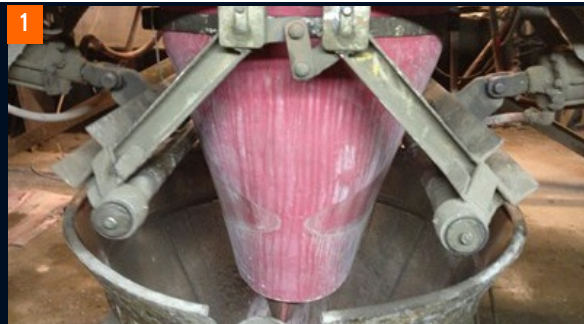
Rubber sock that dispenses concrete into the trucks.

1. Rubber sock
2. Prior to application
3. Complete preparation
4. Completed application

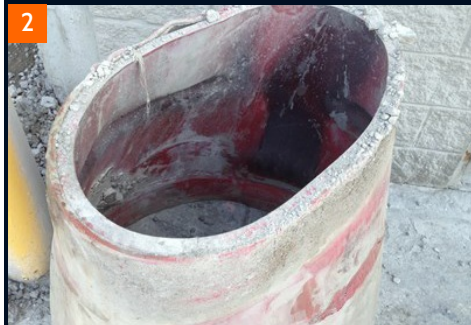
The rubber sock was worn.
