# BELZONA REPAIRS LEAKS IN WATER FEATURE

ID: 5315

Leaks in the water feature.

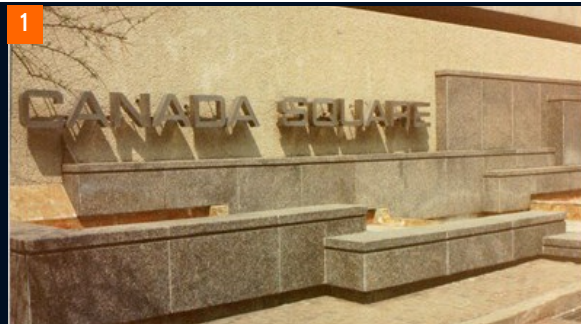
1. Water feature
2. Prior to application
3. Completed application
4. Water feature back online
