# BELZONA PROTECTS AIR DIFFUSER AGAINST CORROSION

ID: 5317

An air diffuser in a warehouse.

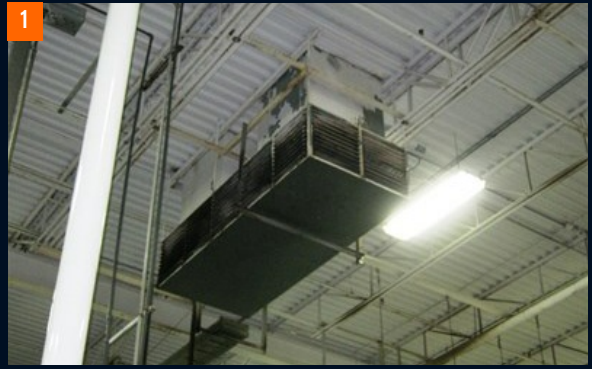
1. Air diffuser
2. Prior to application
3. Application in process
4. Completed application

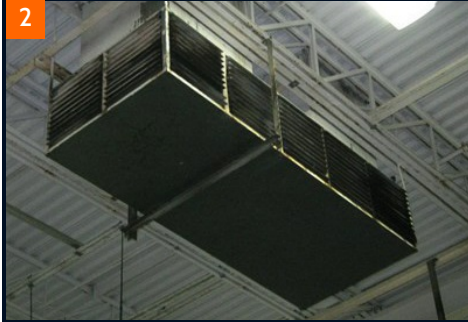
The sheet metal on the air diffuser was suffering from corrosion.

The application was carried out in accordance with Belzona Know-How System Leaflet HEX-12 for protecting supporting steelwork against environmental erosion. The metal surface was prepared using an MBX bristle blaster and vacuum to limit dust propagation. Belzona 3211 was applied using a brush as a two coat system.
