# BELZONA PREVENTS EROSION-CORROSION ON PUMP

ID: 5318

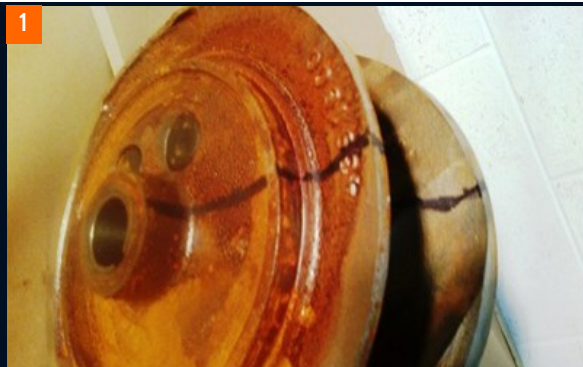
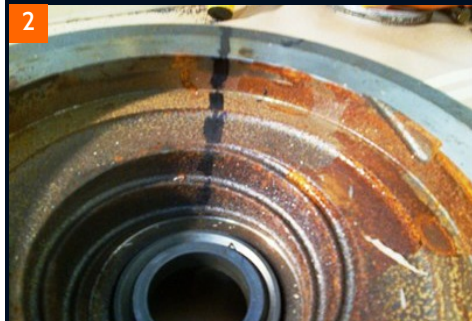
Erosion/Corrosion of the pump volute and impeller.

1. Prior to application
2. Prior to application
3. Completed application
4. Completed application

The application was carried out in accordance with Belzona Know-How System Leaflet CEP-3 for applying internal coatings. The pump was blasted to prepare the surface for application. Belzona 1341 was applied using a brush as a two coat system in accordance with Belzona Instructions For Use.
