# BELZONA STEPS UP TO THE CHALLENGE

ID: 5319

Stairs to a municipal recreational centre.

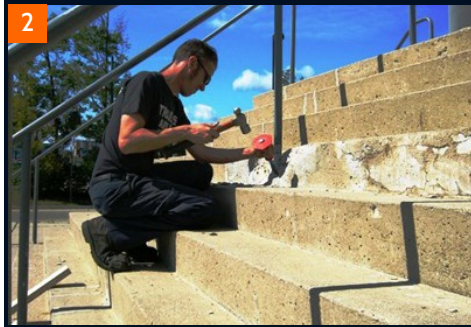
Spalled concrete around hand rail post.

1. Prior to application
2. Preparation in process
3. Application in process
4. Completed application

The application was carried out in accordance with Belzona Know-How System Leaflet FPA-1 for rebuilding worn and damaged floor surfaces. The step around the hand rail was prepared by removing any loose material. Belzona 4911 (Magma TX Conditioner) was applied using a brush and Belzona 4131 was applied directly on to the conditioned surface, initially spreading to a general level using normal screeding techniques and then using a metal straight edge.
