# BELZONA REBUILDS SHAFT ON BLANCHING MACHINE

ID: 532

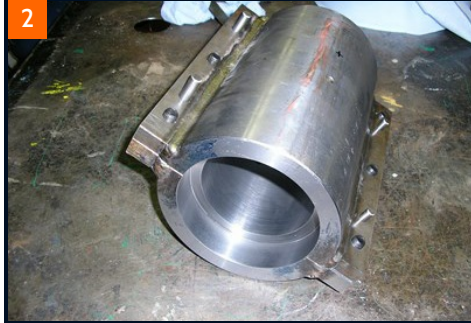
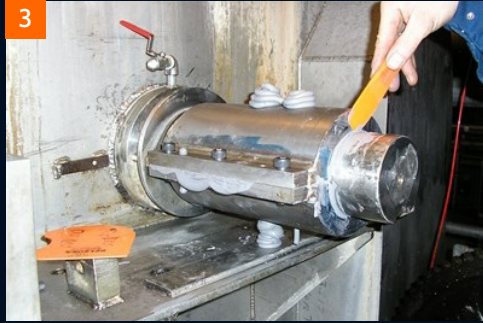
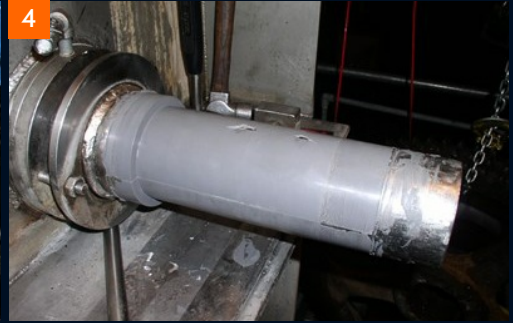
Shaft was worn in the bearing area. This increased pressure on the bearings resulting in a very short service life.

1. View of worn bearing seat area on shaft.
2. View of former. A stepped former was required to allow it to clamp and locate onto undamaged areas of the shaft.
3. Former after clamping in position.
4. Completed shaft rebuild using Belzona 1111. Note the step has been rebuilt as well.

Previously this shaft had been welded up in position and the bearing seat area rough ground back to size. The shaft cannot be taken out without major strip down so an in-situ repair has to be done. The Belzona forming technique produced the precise required diameter.
