# BELZONA REPAIRS AND PROTECTS ROTOR FROM EROSION-CORROSION

ID: 5321

Vacuum pump rotor.

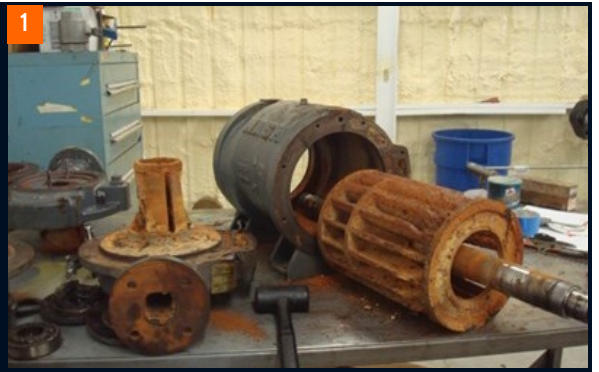
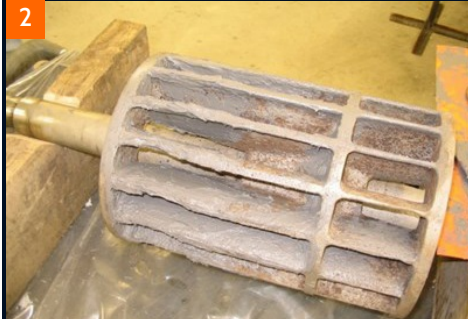
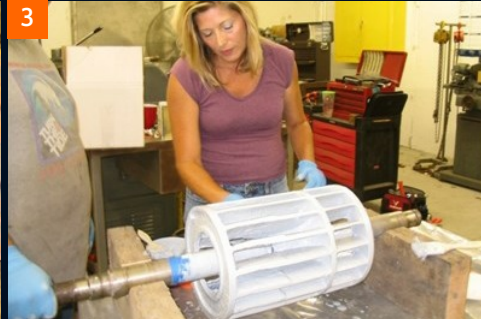
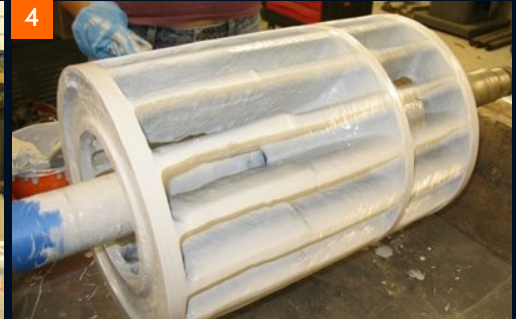
## PHOTOS

During the overhaul of this plant's Nash Vacuum Pump it was determined that the components were showing extreme signs of erosion and corrosion and could benefit from a Belzona renovation.

1. Vacuum pump recently taken out of service for repair
2. Pump prepped to a near white metal finish with steel slag
3. Technical Consultant assisting with the application
4. Completed application and the equipment is ready for installation

The contracted machine shop called us as the pump customer requested Belzona. The maintenance crew were trained, assisted and shown how to complete the repair to our rigid standards. The components were rebuilt with Belzona 1311 and protected with two coats of Belzona 1341; adhering to the custom engineering guidelines published in Belzona Know-How System Leaflets FBC-2 & FBC-15.
