# BELZONA REPAIRS AIR HANDLING EQUIPMENT

ID: 5322

## PROBLEM

One of the bearings on this office building's air handler system failed and severely gouged into the fan's shaft. The cooling system was nearly crippled with a triple digit, Midwest July heat.

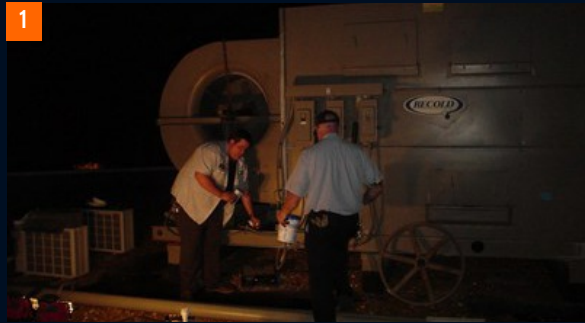
1. Air handler fan threw a bearing in the early a.m.; building without conditioned air for over 12 hours.
2. Customer secured the shaft for early a.m. repair.
3. Belzona repair completed before 6:00 a.m.
4. Completed application of shaft and ready to return to service that morning.

The shaft was supported and the pillow block was removed, exposing the damaged area. A suitable former was treated with Belzona 9411 and the bearing surface was roughened and degreased. Belzona 1111 was mixed and applied, then the form was clamped in place. After a short cure, a new bearing was installed and the air handler was placed back on-line. The application was carried out in accordance with Belzona Know-How System Leaflet MPT-2.
