# BELZONA REPAIRS A DAMAGED SHAFT

ID: 5324

Rock crusher shaft.

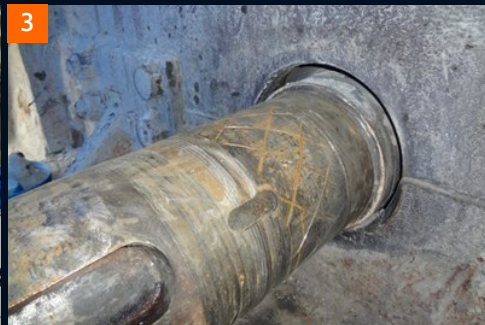
During the bearing replacement on the rock crusher of this large quarry operation, it was noted that the shaft had been worn undersized.

1. Overview of the Plant
2. Rock crusher platform
3. Damaged rock crusher shaft
4. Completed application on the shaft

A trained machine shop fabricated a split former to exact dimensions and the shaft was quickly repaired in-situ with Belzona 1111. The application was carried out in accordance with Belzona Know-How System Leaflet MPT-2.
