# BELZONA REPAIRS DAMAGED SHAFT

ID: 5325

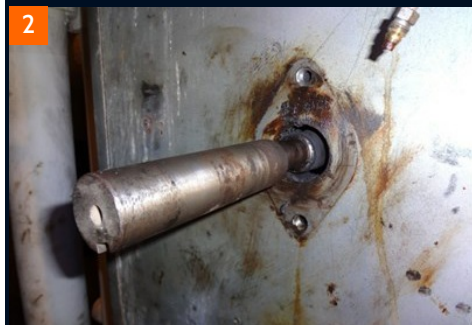
Bearing failure on the air handler for the main lobby of this busy downtown hotel wore into the shaft so severely that the cooling system was out of commission as the Spring weather was heating up.

Air handler bearing failed, gouging shaft.

1. Hotel storefront
2. Damaged shaft
3. Consultant assisting staff engineer with Belzona 1111
4. Completed application

A trained machine shop fabricated a split former to the exact dimensions and the shaft was quickly repaired in-situ with Belzona 1111. The application was carried out in accordance with Belzona Know-How System Leaflet MPT-2.
