# A DURABLE BELZONA COATING FOR CONVEYOR

ID: 533

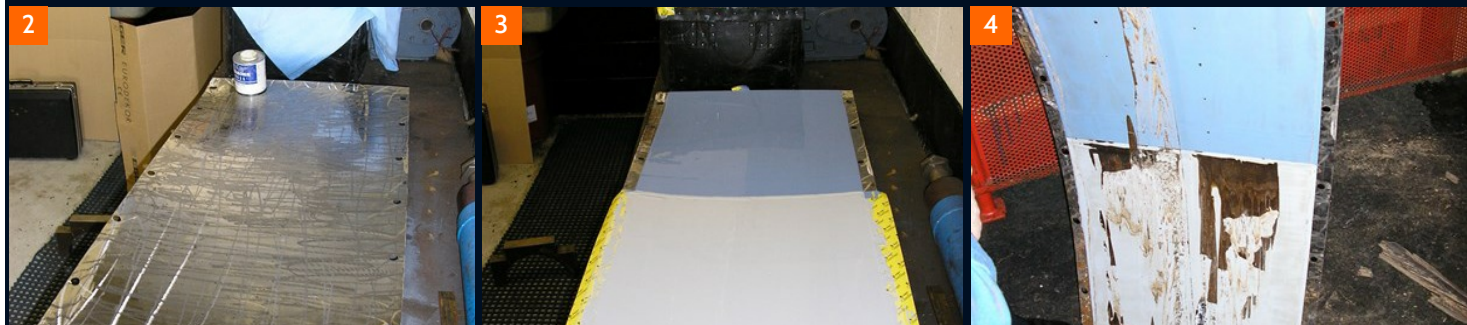
## PHOTOS

Conveyor suffering build up of product causing flights to drive up into conveyor ceiling. Customer sought to reduce the excessive maintenance down time through the use of Belzona.

1. Conveyor with product build-up clear to see
2. Plate prepared for application of product
3. Product applied to conveyor bottom
4. Conveyor bottom removed to prove performance of Belzona 1341

Since application of Belzona® 1341, the issue of build-up on the conveyor has been stopped - putting an end to time consuming maintenance that was carried out every five weeks and took four maintenance personnel. This also increased potential production time on this piece of plant equipment.
