# BELZONA SECURES AERATION BASIN JOINTS

ID: 5330

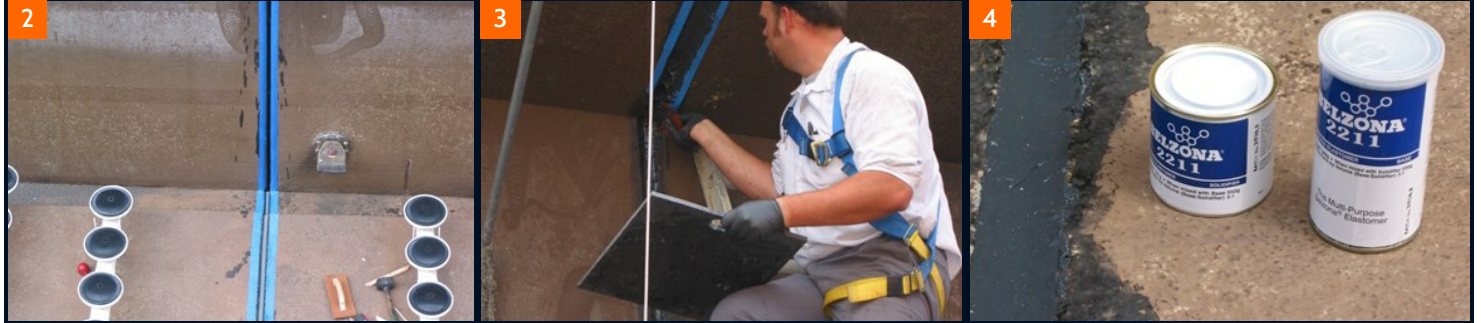
## PHOTOS

The client was aware of Belzona's quality and sought use of appropriate Belzona materials to seal leaking expansion joints. Existing material was of poor quality and had torn away from joint sidewalls.

1. Aeration basin overview
2. Masking, backer rod & conditioner applied
3. Application to overhead & vertical wall surfaces
4. Completed joint

The application was carried out in accordance with Belzona Know-How System Leaflet FPA-6. A foam backer rod was inserted to expansion joint the proper depth. Belzona 2911 was used to condition the surface area and Belzona 2111 was hand applied to seal the expansion joint.
