# BELZONA OFFERS PROTECTION BY SEALING INSULATOR BASES

ID: 5331

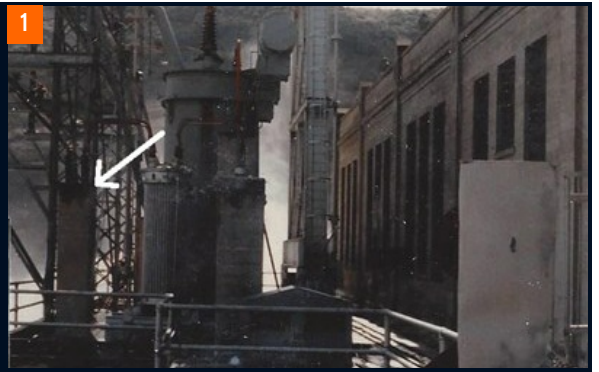
The bases of the insulators had been sealed and re-sealed many times but it never lasted long, thus water would begin to leak through the base. The switch gear below carries 100,000 volts of electricity which would not react well if the water hit the wrong spot.

1. Arrow shows damaged area
2. Applying Belzona 3911
3. Brushing on reinforced Belzona 3111
4. Brushing on reinforced Belzona 3111

Loose tar was removed. Belzona 3911 was brushed on the concrete and Belzona 3921 was brushed on the insulator. Two coats of Belzona 3111 were brushed on, incorporating reinforcing sheet in the first coat. The application was carried out in accordance with a modified version of Belzona Know-How System Leaflet GSS-3.
