# BELZONA PROTECTS DIESEL FUEL BAY WITH NON-SKID FLOORS

ID: 5333

Fuel bay floor at bus depot.

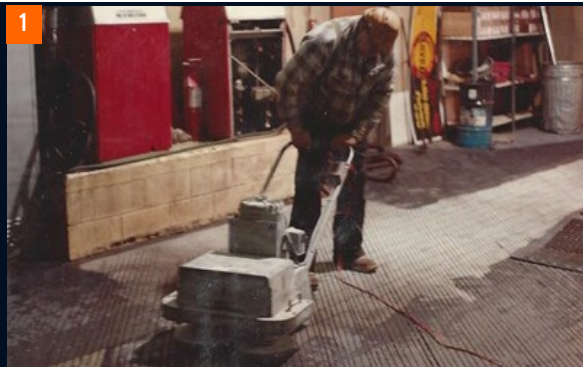
1. Grinding the surface with a stone grinder
2. Brushing on Belzona 4411
3. Completed application of test patch

The floor was pressure washed to remove the remainder of previous non-skid products and the spilled diesel fuel. A propane torch was used to lightly heat the concrete, drawing out more diesel fuel from the concrete. The floor was pressure washed a second time. A stone floor grinder was used to remove the surface laitance then Belzona 4411 was brushed on, sprinkling aggregate on top. The application was carried out in accordance with Belzona Know-How System Leaflet FPA-8.
