# BELZONA EXTENDS THE LIFE OF A WATER PUMP

ID: 5334

Water Pump.

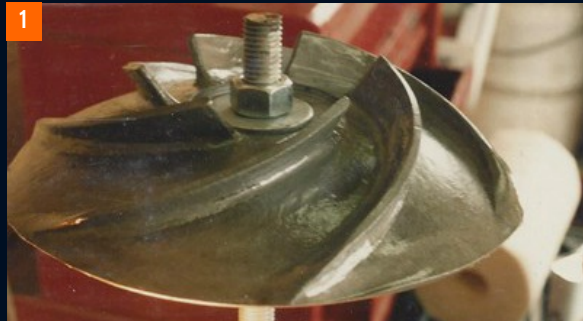
1. New impeller blasted and conditioned
2. Impeller coated with Belzona 2131
3. Two coats of Belzona 1321 applied to casing

The new pump was grit blasted. Belzona 4911 was applied to the impeller and allowed to cure. Belzona 2131 was brushed onto the surface. Two coats of Belzona 1321 was applied to the casing. The application was carried out in accordance with Belzona Know-How System Leaflets CEP-1 & CEP-3.
