# BELZONA REPAIRS PILLOW BLOCK SHAFT

ID: 5335

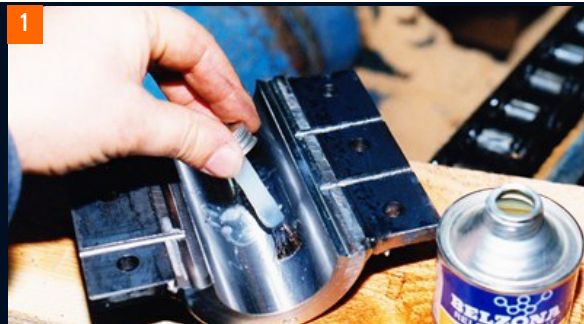
1. Applying Belzona 9411 to the former
2. Sweating the oil out of the steel shaft using a torch
3. Bolting the former in place
4. Dressing down Belzona 1111 with emery cloth

A former was made at the in-house machine shop in accordance with a modified version of Belzona Know-How System Leaflet MPT-2. Note the relief grooves down the side of the flanges. The former received two coats of Belzona 9411, then Belzona 1111 was applied. The shaft was ground and Belzona 1111 was applied. The former was bolted in place and Belzona 1111 was allowed to cure. After 2 hours, the former was removed, the excess of Belzona 1111 was dressed down with emery cloth and the new bearing installed.
