# BELZONA GIVES NEW LIFE TO PUMP CUTWATER

ID: 5336

Potato plant water pump.

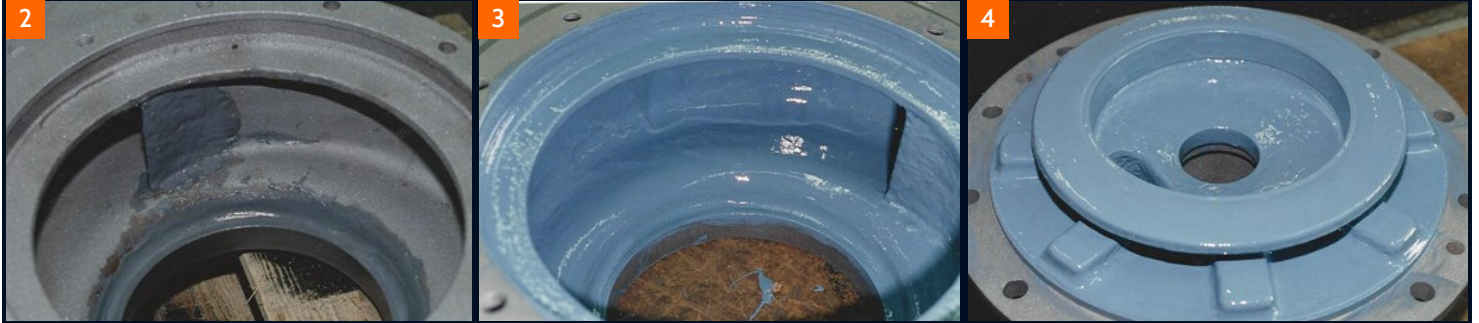
The worn cutwater had reduced the performance ability of this pump.

1. Worn cutwater
2. Cutwater rebuilt, ready for coating
3. Pump casing with two coats of Belzona 1341
4. Pump casing with two coats of Belzona 1341

The pump casing was grit blasted. The cutwater was rebuilt in accordance with Belzona Know-How System Leaflet CEP-1. The pump casing was coated with two layers of Belzona 1341.
